RESTORING MEANDERS TO STRAIGHTENED RIVERS

1.1 New meandering channel through open fields

RIVER COLE

LOCATION - Coleshill, (Oxon/Wilts border) SU 234935

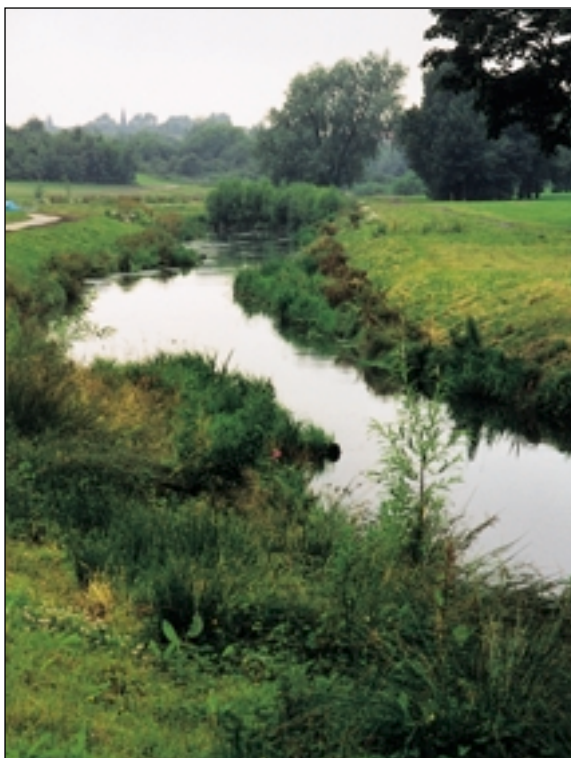
Type A deflector
– vegetation established

The primary difficulty was experienced when setting the level of the deflectors in relation to the normal range of low water levels; a critical factor. Deflectors were installed at the start of extensive river restoration works further downstream, when water levels were temporarily raised. Consequently, the 'type A' deflectors were set higher than designed and 'type B' were set lower. Live willow logs were used in 'type A' and inevitably began to grow, threatening to cause obstruction to flood flows.

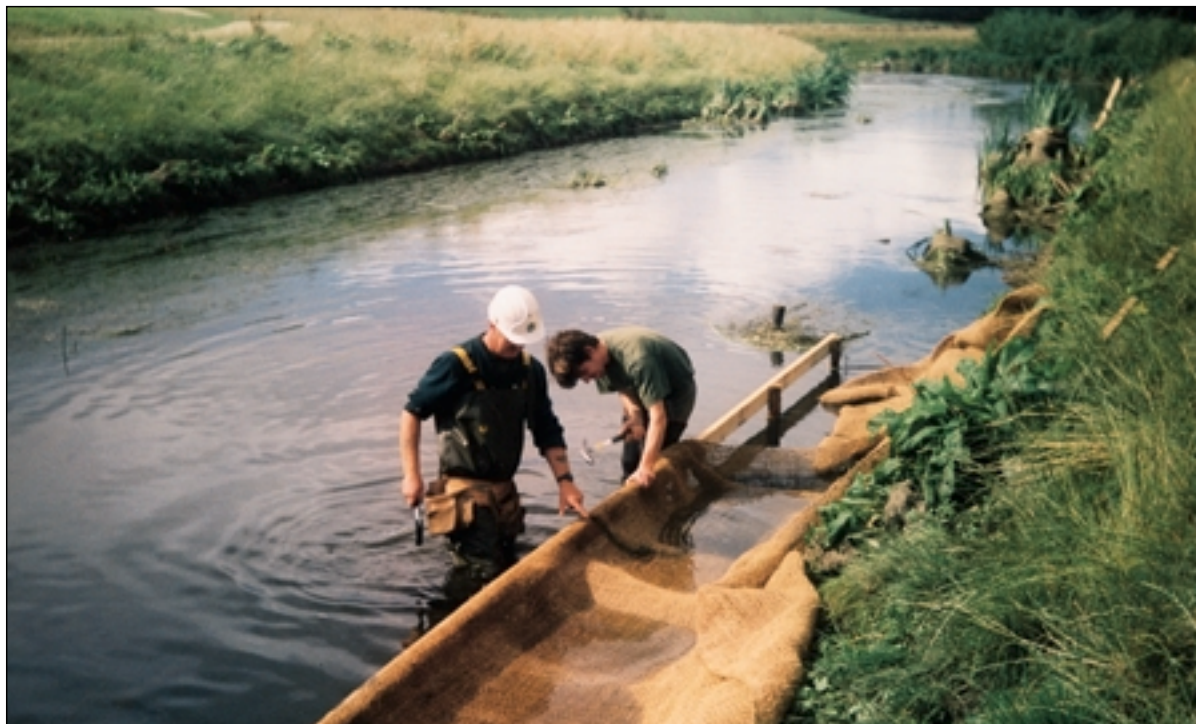
Attaching coir matting to create Type A ledges on River Skerne

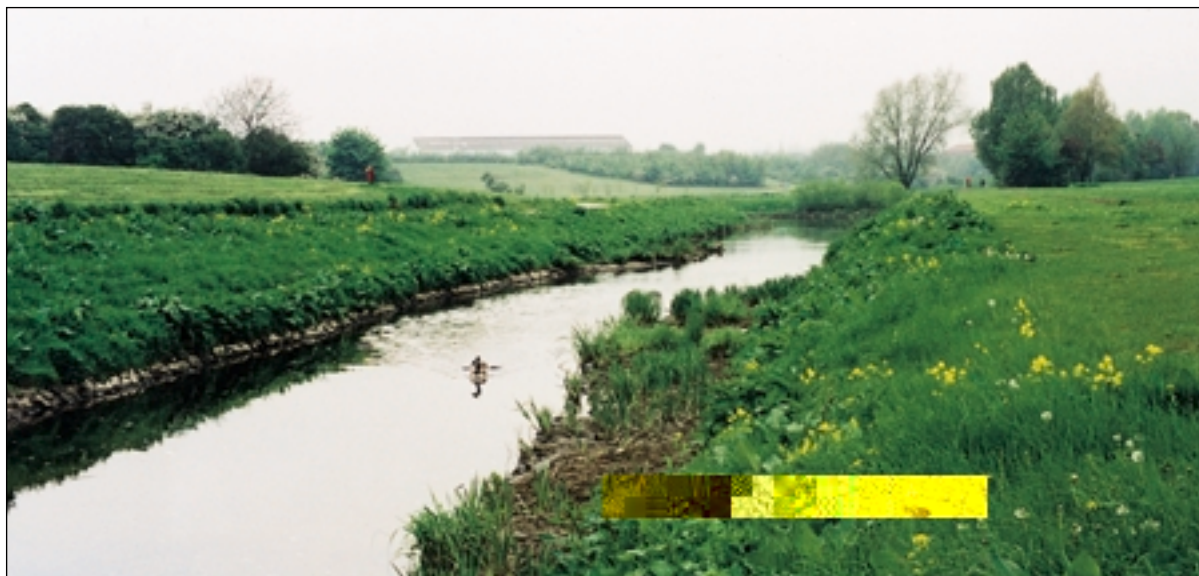
Type A Ledge on the Skerne – May 1998

Type A margins using plant pallets were installed downstream of the footbridge in the autumn of 1997 and overwintered satisfactorily in dormant conditions after several floods. Early summer 1998 growth was patchy with some silt banks smothering pallets. Growth was sufficient to ensure the spread of species to generate the dense cover required. Notable species that survived include occasional purple loosestrife and meadowsweet.

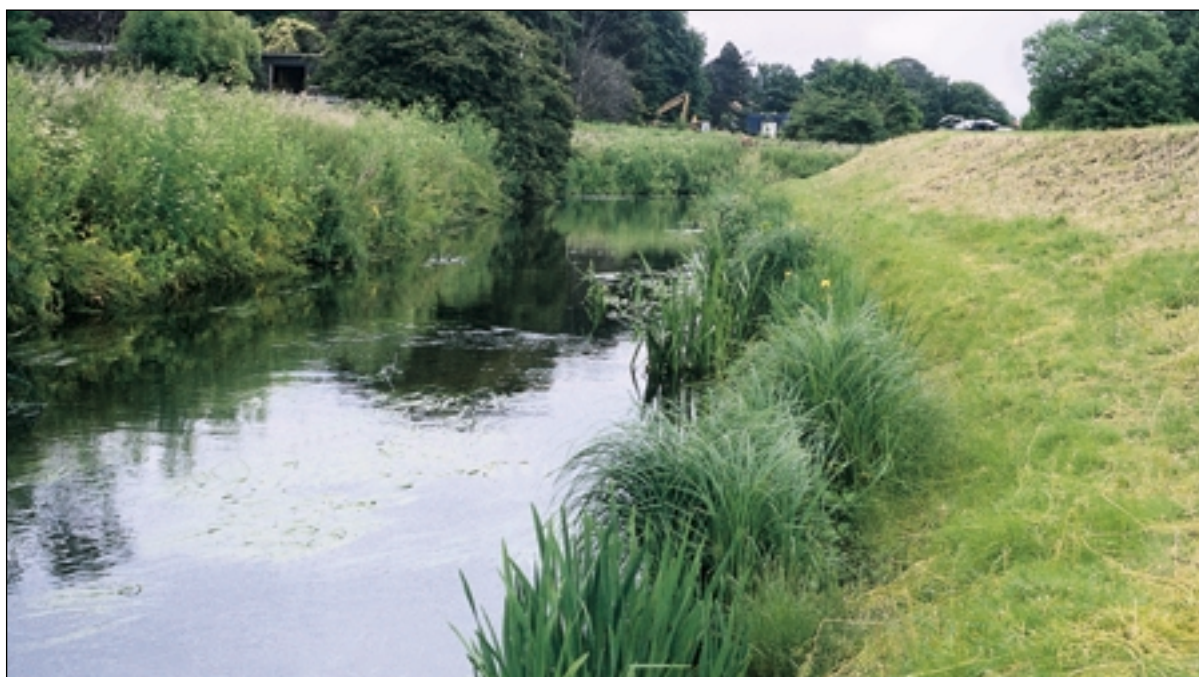
Type B Ledge on the Skerne after 2 years

Type B margins utilising plant rolls were installed upstream of the footbridge in August 1996. In 1998 they are attractive features much favoured by resident ducks that have created some bare patches between well established runs of lesser pond-sedge, yellow flag and reed canary-grass. The attraction of silt within the overwinter dormant vegetation along the ledges is significant; ledges have built up by as much as 300mm in places before being assimilated within new spring growth.

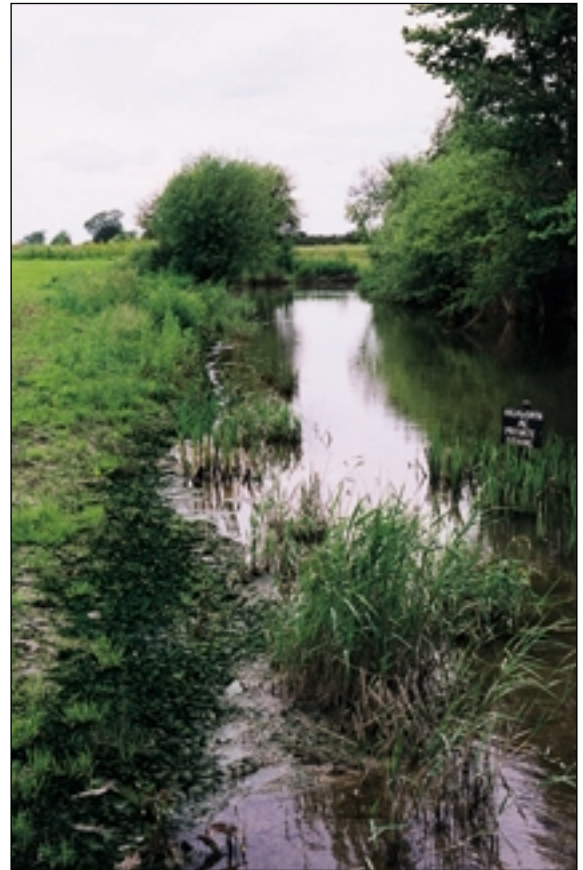
Type A and B ledges on the Cole after one winter

The ledges overwintered well in dormant conditions with no structural damage by floods although little more than 50% of the plants appeared to have survived to grow on during summer. The ledges are developing very well (1998) and creating both emergent vegetation habitat and landscape enhancement in the short stretch of river that previously had the least habitat and visual amenity value.

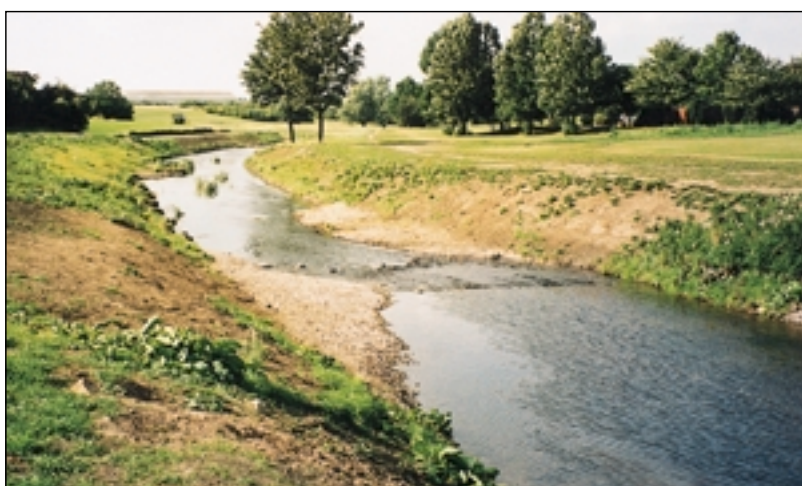
Stone Riffle downstream of
Hutton Avenue footbridge

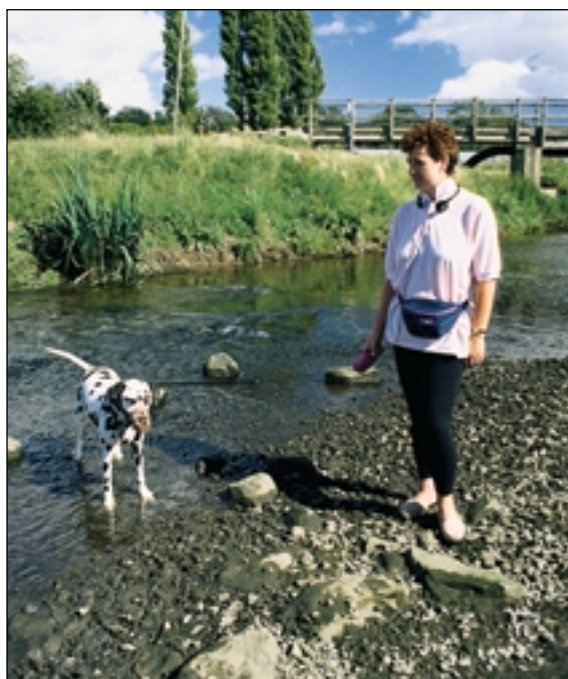
The riffle allows easy access
down to the river
– November 1996

Of particular note is the popularity of this spot with children who can gain safe access to the river and paddle in the shallow water, where the bed is firm and stoney.

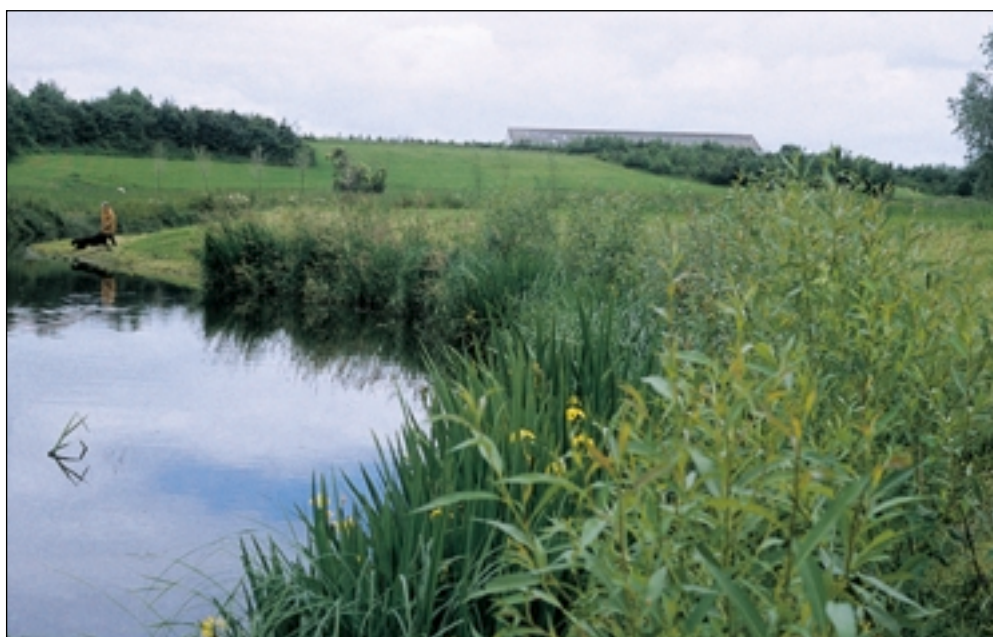
Willow spiling 2 years after construction

The river banks at both entry and exit sites are stable and silts are accumulating around a dense line of willow shoots up to 2.5m tall. The planted ledges are equally densely covered with marginal aquatic species that are similarly accumulating silts. Exceptionally, growth over one short length has been limited to the willow posts introduced behind the spiling. This is because the spiling poles, installed in the autumn, had been stored for too long in dry conditions.

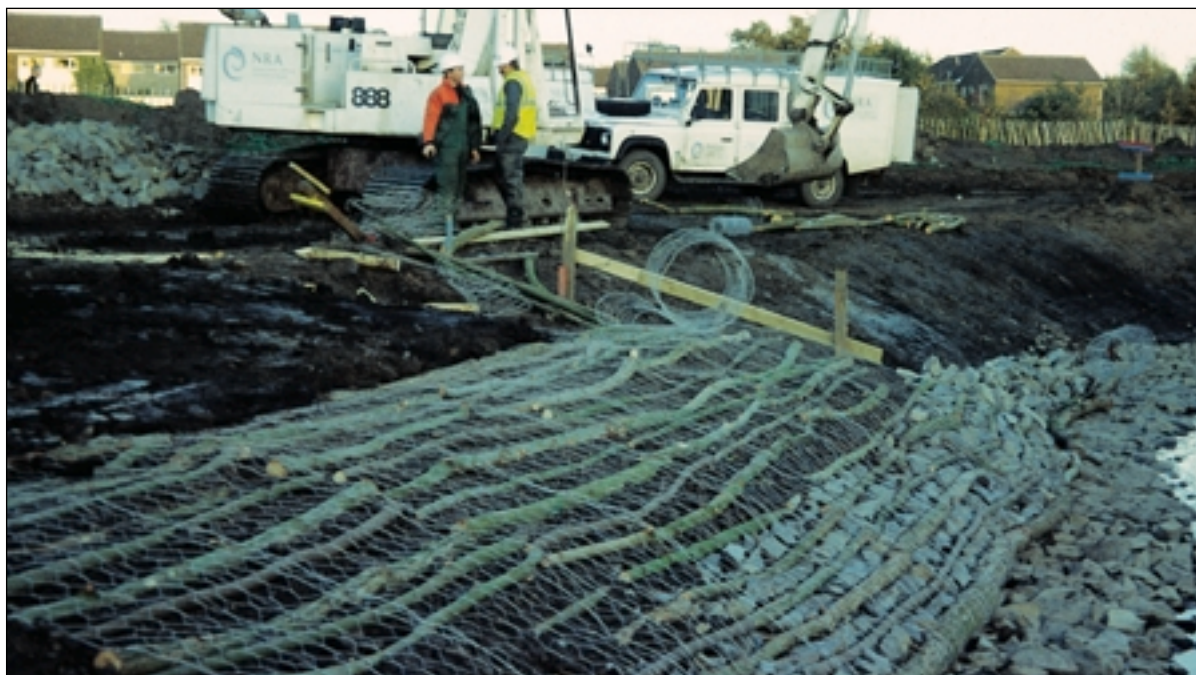
Mattress revetment under construction – October 1995

NOTE: Additional poles inserted to close up spacing after photo taken

Selected live crack and white willow poles, 50-100 diameter, were then laid horizontally all along the face of the fill and pressed into it. Finally the free ends of the netting were drawn tightly over the poles and secured to stakes driven well back in the fill. Due to the shortage of willow locally, up to 30 % non-regenerative sycamore was incorporated intermittently. The netting was stapled to the poles to create a structurally integral unit.

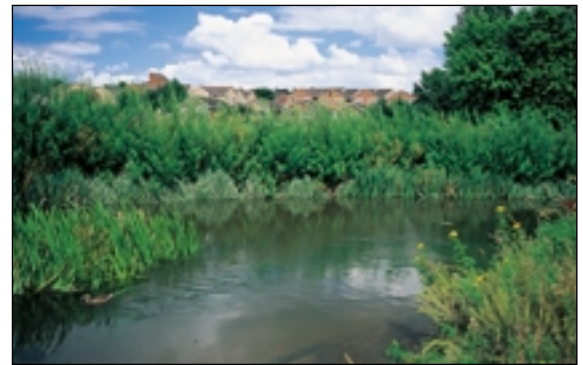
Mattress revetment after 2 years

Due to autumnal installation, no growth of willow occurred for the first 6 months, when winter floods washed out some soil. Since then the situation has reversed and silts are accumulating within the willow whilst roots extend into underlying soils and rock.

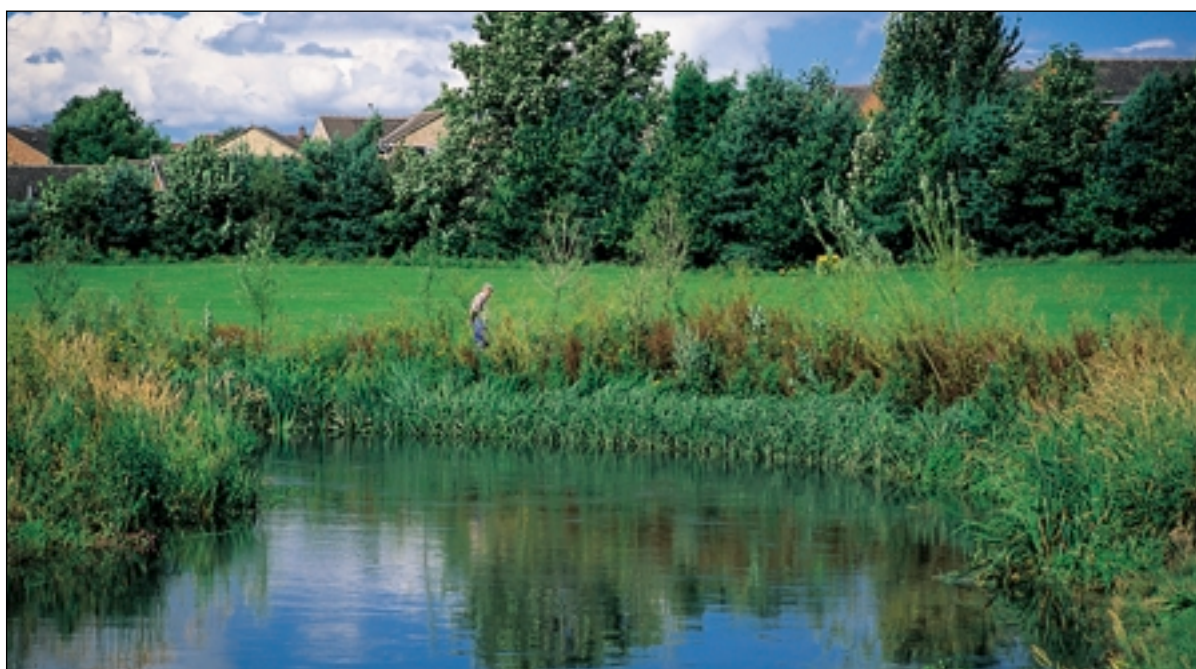
Log toe revetment three years after construction

This technique was used in two locations and both have performed well with dense willow growth up to 2m high along the bank and a thick margin of plants along the water's edge, all of which are accreting river silts in successive floods. Rooted willow plants established much more strongly than unrooted slips, but this is not uncommon with the grey/goat species selected. Other willow varieties are known to strike readily from slips. Species that are indigenous to the site are always preferable. Brushwood containing willow cut locally can be built into the lower banks as an alternative to the geotextile utilised at the Darlington site which was virtually barren of trees.

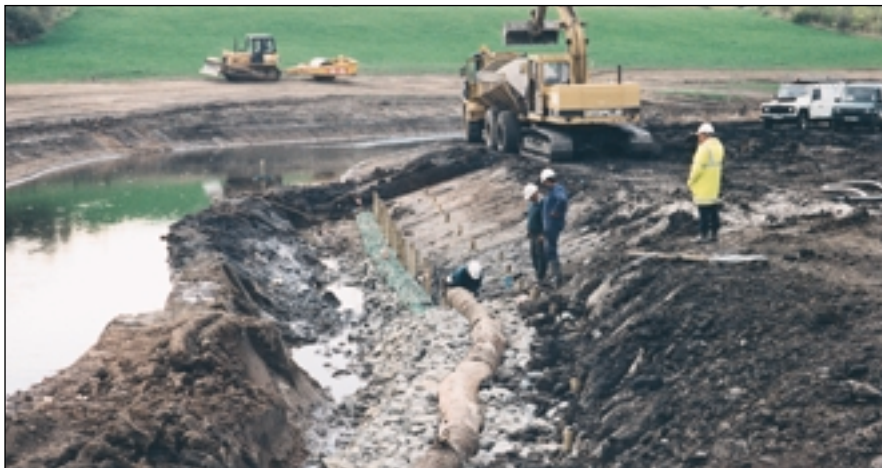
Log toe revetment during construction

This technique demonstrates revetment using tree trunks or large boughs along the water's edge to stabilise the toe of reformed banks. Proprietary nylon geotextile is used to revert the bank above the logs so that willow plants can safely be established within it. Revetment was needed to protect a gas main in the bank and loose backfill closing off a length of redundant channel.

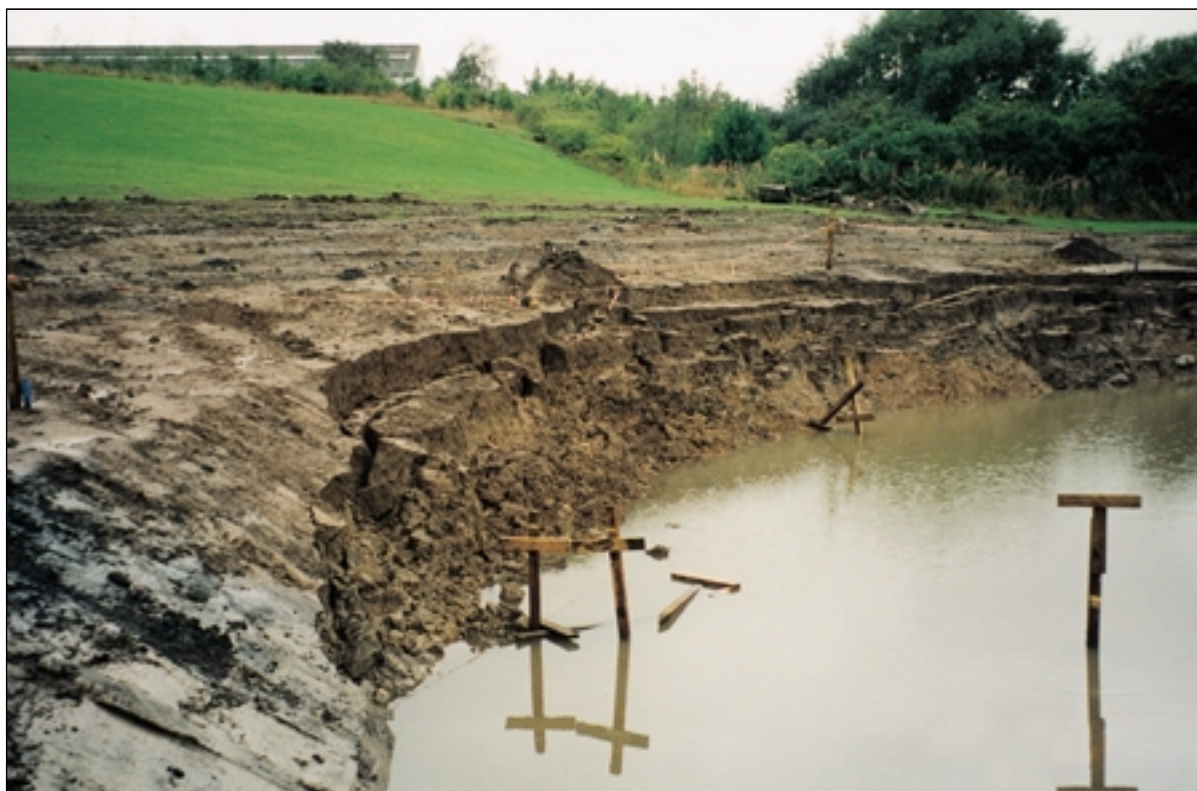
Slipped slope during work – September 1995

During works, water seepage from gravel at the bottom of a newly excavated river bank caused it to slip. As the bank was close to banded industrial fill, repair was necessary. The route of a proposed footpath was also at risk if this bank remained unstable.

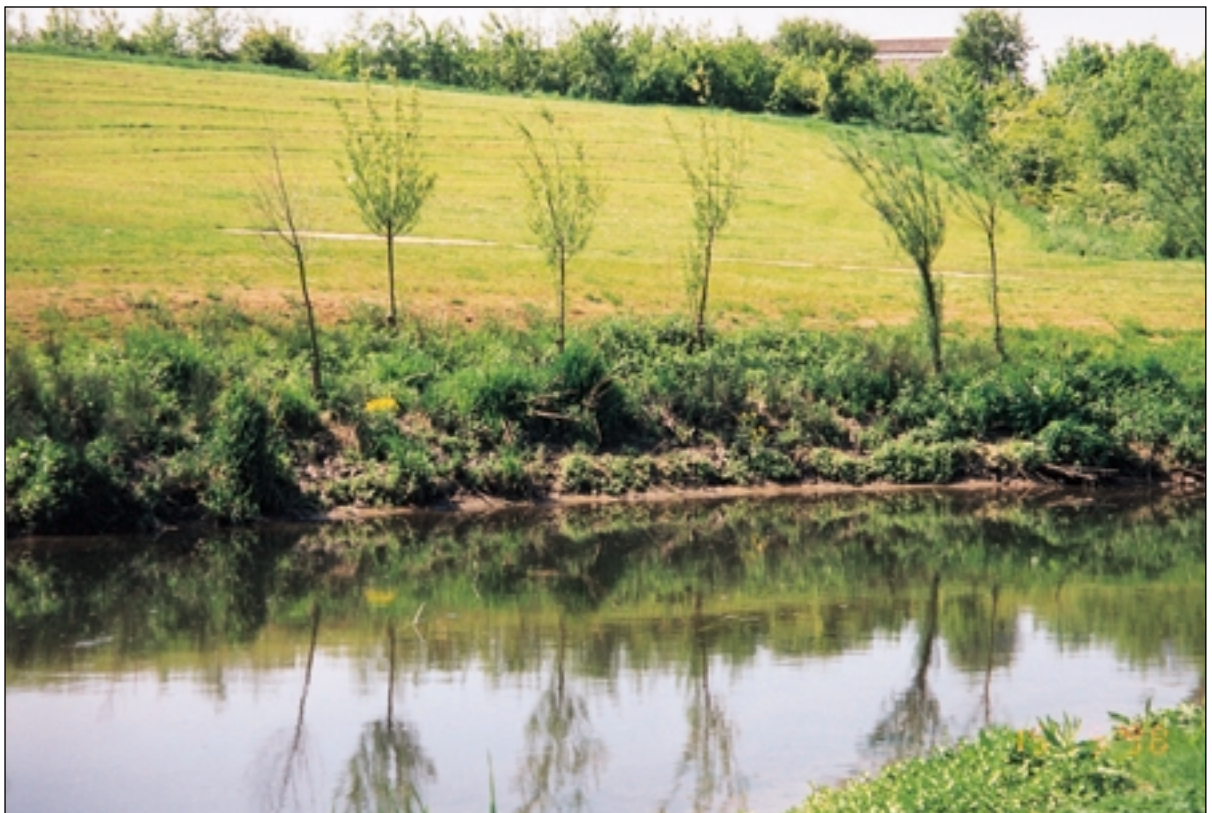
Slipped slope 2 years after repair – 1997

The bank slip has remained stable and appears natural with no visible signs of support. Water continues to seep from the bank and maintains a small wetland habitat on the ledge above river level.

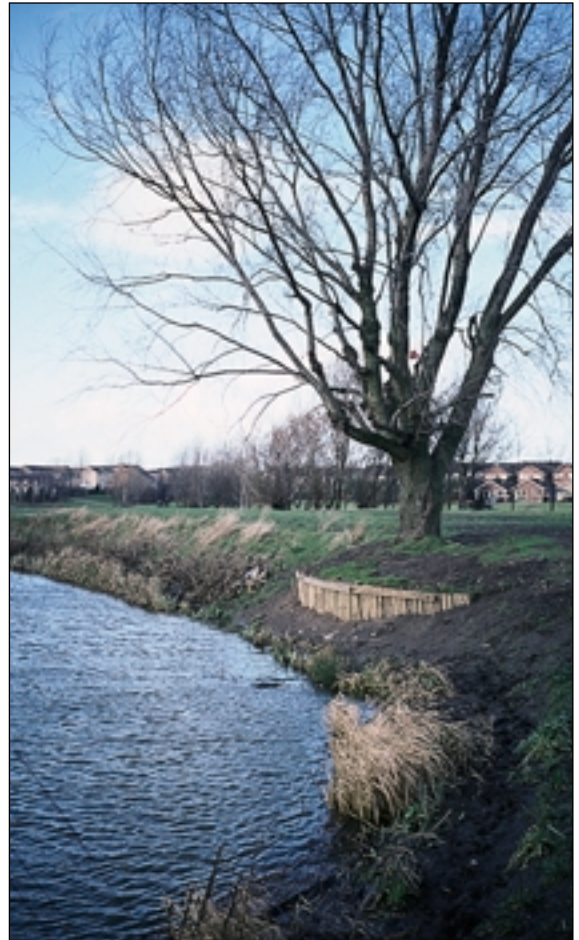
Protected roots after work completed – February 1997

The revetment of the exposed roots has performed well, following many high flows since its construction. The roots are no longer exposed and the turf and other planting has grown to give added protection. Well used by a variety of people, the structure has become a seating area providing shade.

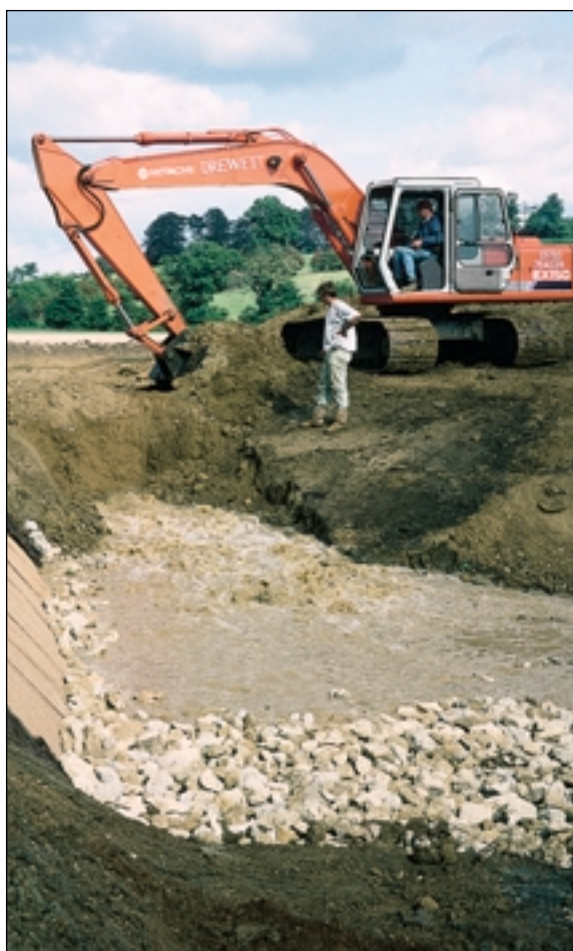
Construction of coir matting revetment
– river being released

Coir was installed on both banks at the crossing located mid way between the ford (ch. 280m) and the stock bay (ch. 100m), as well as opposite the large backwater. Hurdles were installed opposite the small backwater. A plan of the reach can be found in 1.2.

Points of note are that all joints between individual hurdles or matting were overlapped downstream to avoid lifting in high flows and each run of revetment was securely fixed within undisturbed soils at each end. A single willow hurdle was pegged down over each end of the coir matting for additional security, but some have washed away (without damage to the coir) suggesting they were not necessary. The stone bed was sized 100mm -150mm and spread up to 300mm deep.

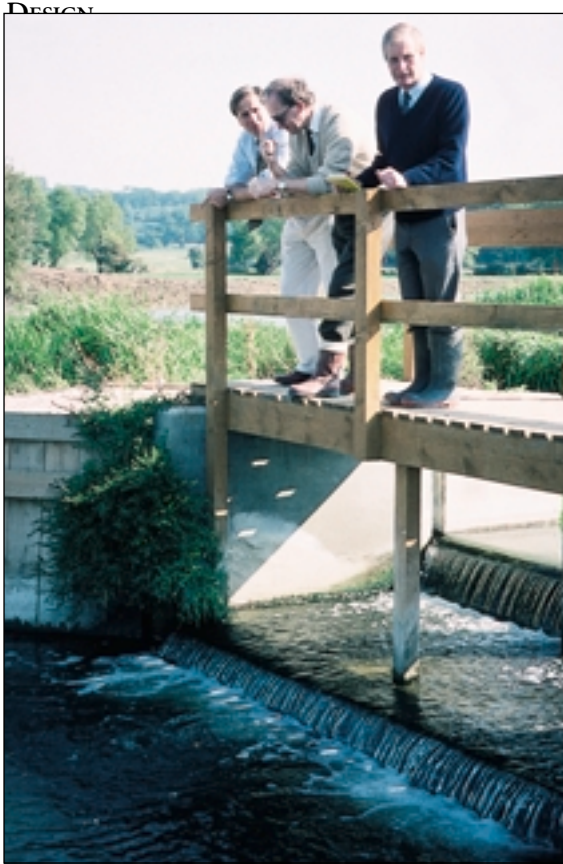
Control weir (location ① on plan)

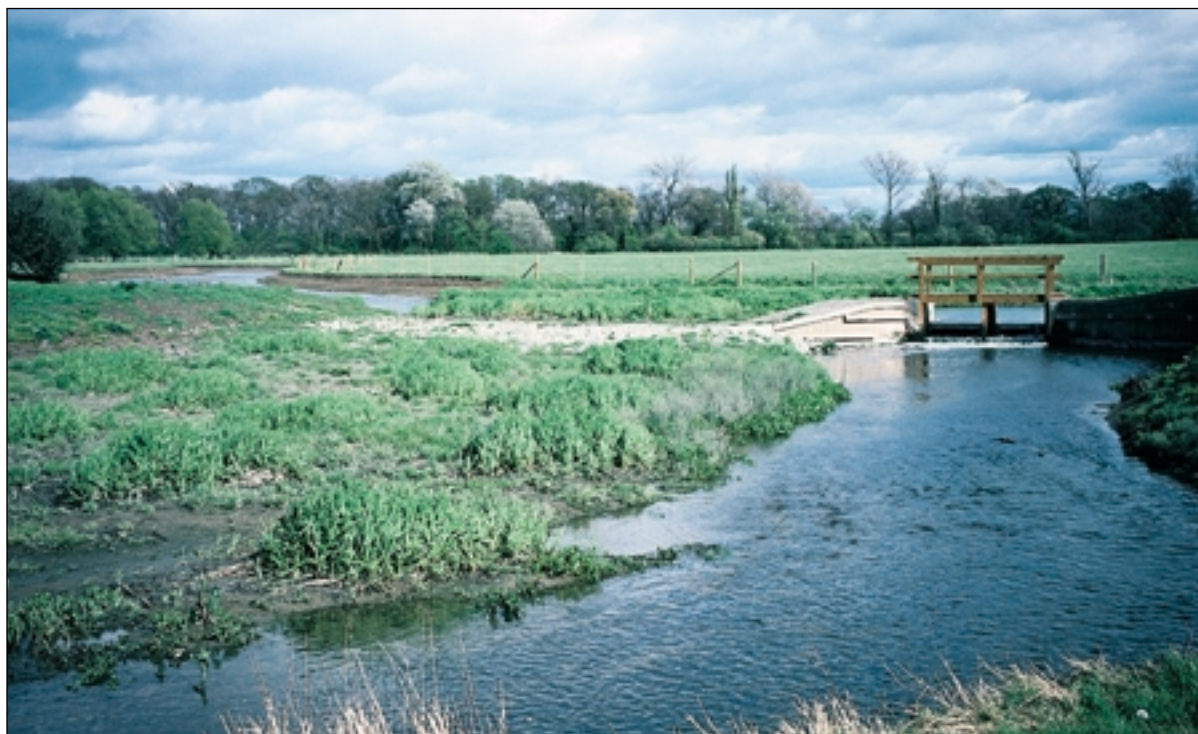
Spillway alongside bifurcation weir
– April 1997

The hydraulic capacity of the flume is small (to suit base flows) so a 10m wide spillway is incorporated alongside to feed sufficient floodwater to fill the new channel. The crest level is only 0.1m above the normal water level in the leat so it operates frequently. Below the spillway, a large area of land is gently graded out towards the new channel which sustains marshy conditions around its inner margins. This low lying area is largely flooded before overspill occurs, ensuring a fairly smooth combining of floodwaters passing downstream. Water in the new channel rises quickly, ensuring the overspill is completely submerged (drowned) at an early stage of a rising flood, thereby further reducing scour potential.

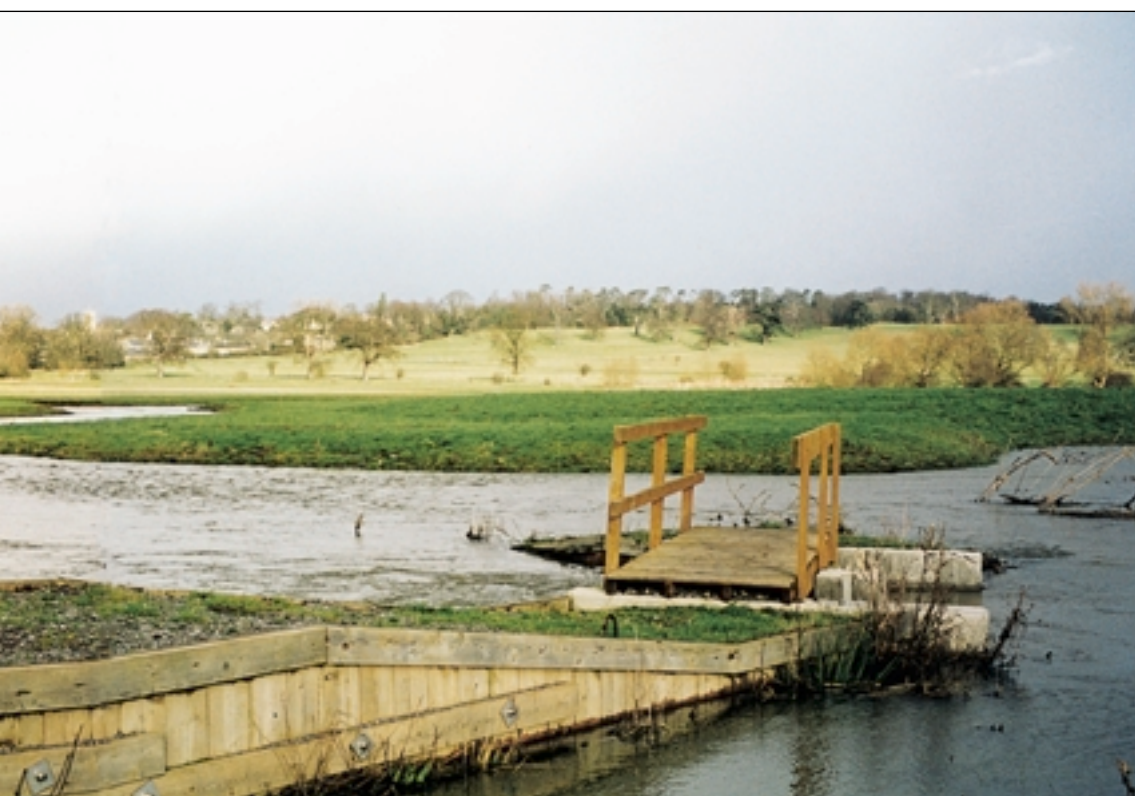
Flood filled channel
downstream of
bifurcation weir

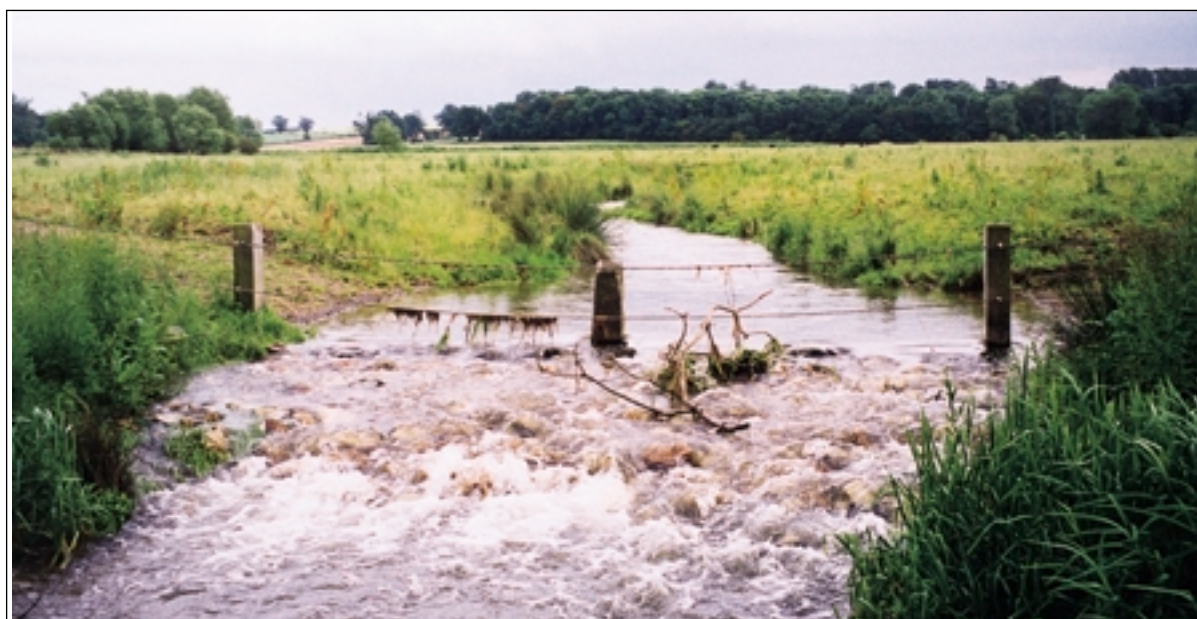
Weir and rock apron

New river channels that were created both upstream and downstream of Coleshill Mill have bed levels that are elevated c. 1 m higher than the bed of the existing channels into which they now flow (see 1.1 – 1.2). Measures were needed to stabilise the river geometry at both confluence points because of the sudden change in bed levels. Drop-weirs were built at each.

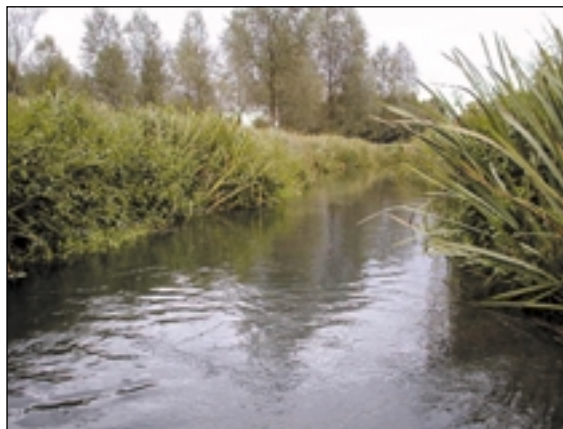
Before: sluggish deep water with encroaching sedge

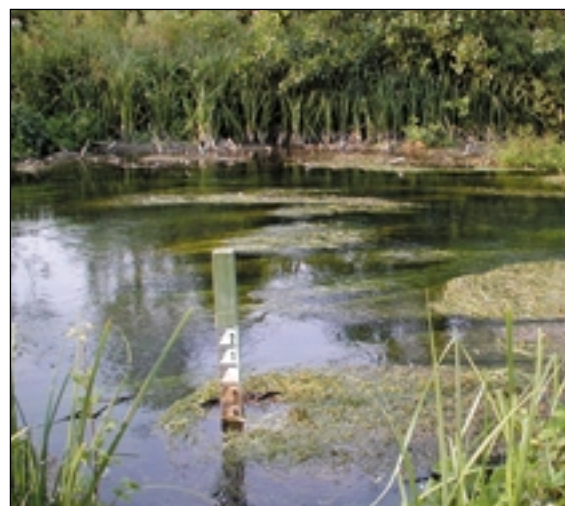
Gravel placement may influence or be influenced by fluctuating water levels

Work was scheduled to commence in early October when river flows are usually at an annual low, approximating to Q90. Prior to undertaking work, stakes were placed in the river to mark this level as a guide to the contractor during the gravel placement process. This was especially important since water levels would change if silt entrapment measures had needed to be installed downstream (on standby but not needed).

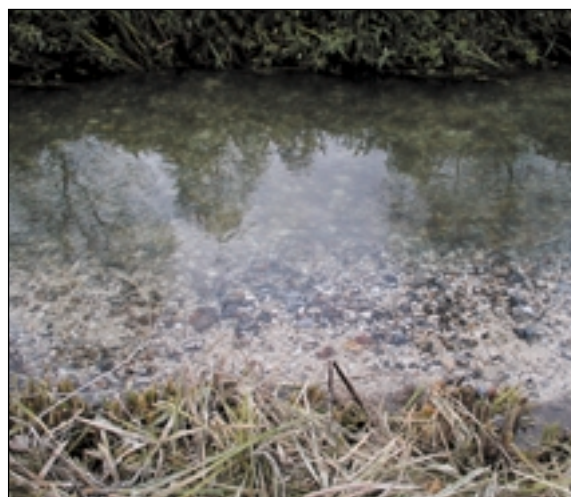
Flinty gravel used to narrow and raise the river bed

The material used to shallow the channel depth was chalky and gravel flints. Where possible it is advisable to use material from the immediate area to reflect the type of bed that would have been present under natural conditions. Here the gravel fill was excavated from the floodplain by the creation of an adjacent pond on the right bank. The suitability of the material was checked beforehand by the inspection of machine-excavated trial pits. Infill material was predominantly a mixture of gravels and flints varying in size from 20 to 10mm, with <5% coarse sand and minimal silt. A few larger flints were also present.

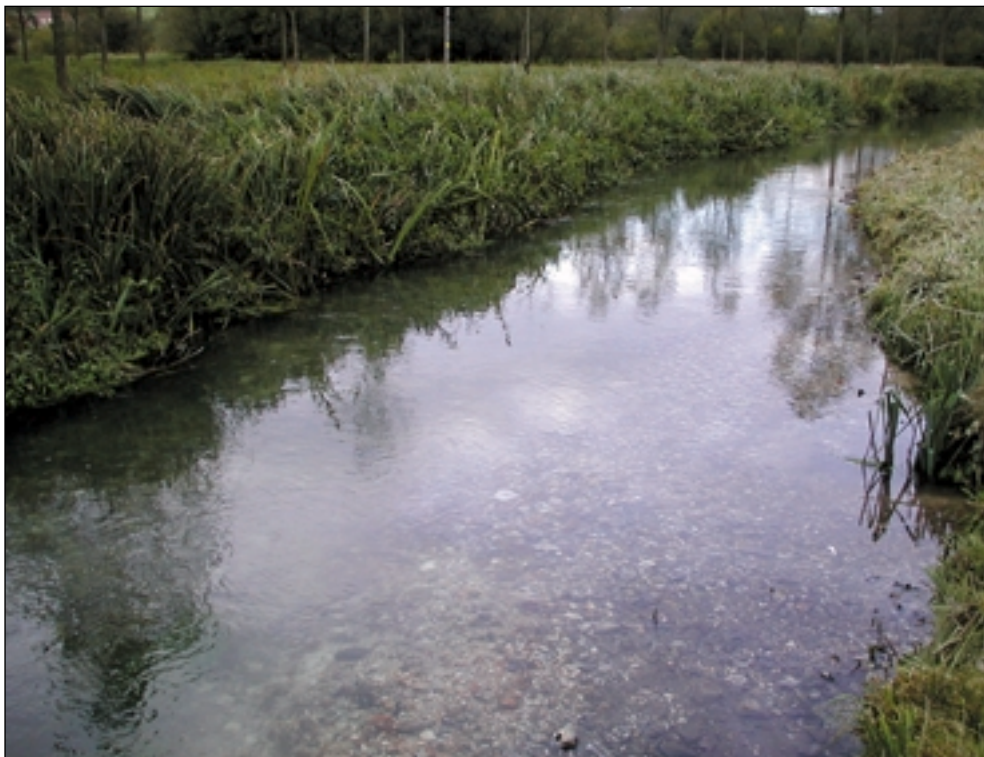
A few months after completion, the raised bed evident

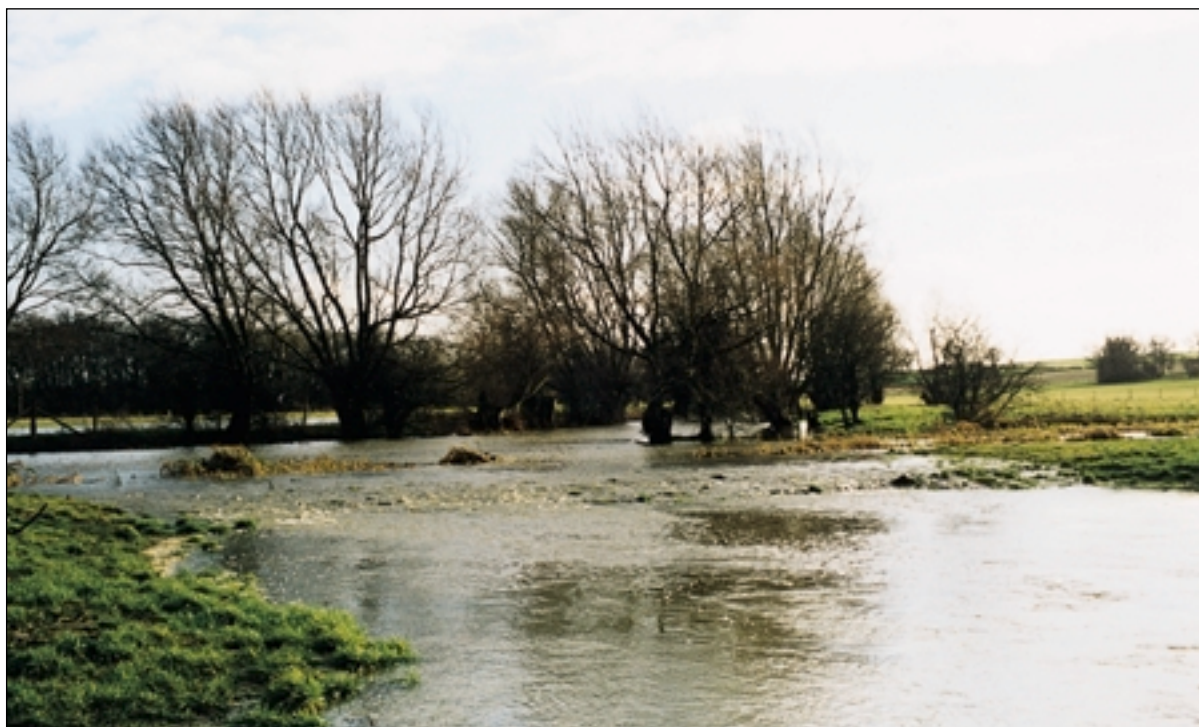
Spillway **S2** in flood

Spillway S2 begins to operate only after S1 has filled the new channel with water. Water spilling over S2 passes directly into the new channel causing it to overflow its banks and initiate field flooding. Scour of the overspill is minimal because this design ensures floodwaters from both S1 and S2 merge without excessive turbulence.

The level at which S2 is set is critical; it is 300mm lower than the floor of the mill further down river, to ensure floodwater is diverted away from the mill. In practice, S2 replaced an unsightly concrete cascade weir built at the mill to protect it from flooding. The cascade has been boarded off and will be infilled once the performance of S2 is proven to be satisfactory.

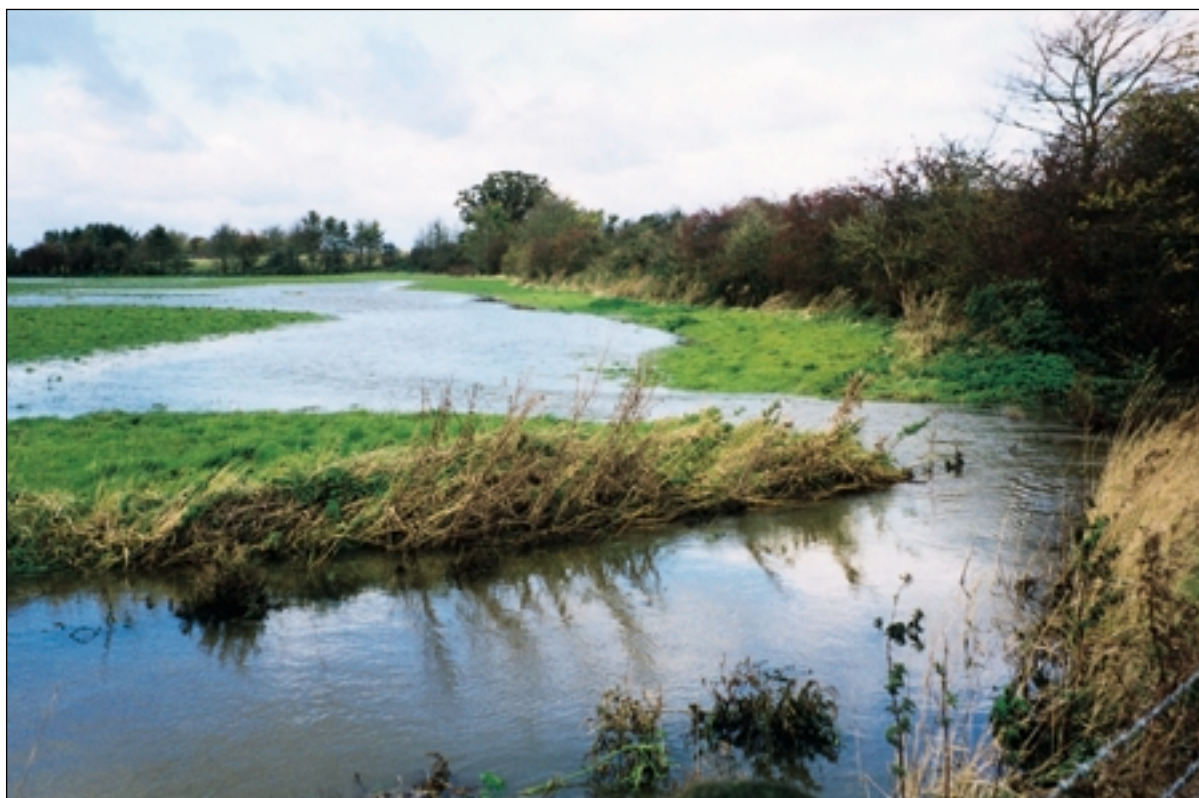
Spillway **S4**. Floodwaters spilling into field gully.

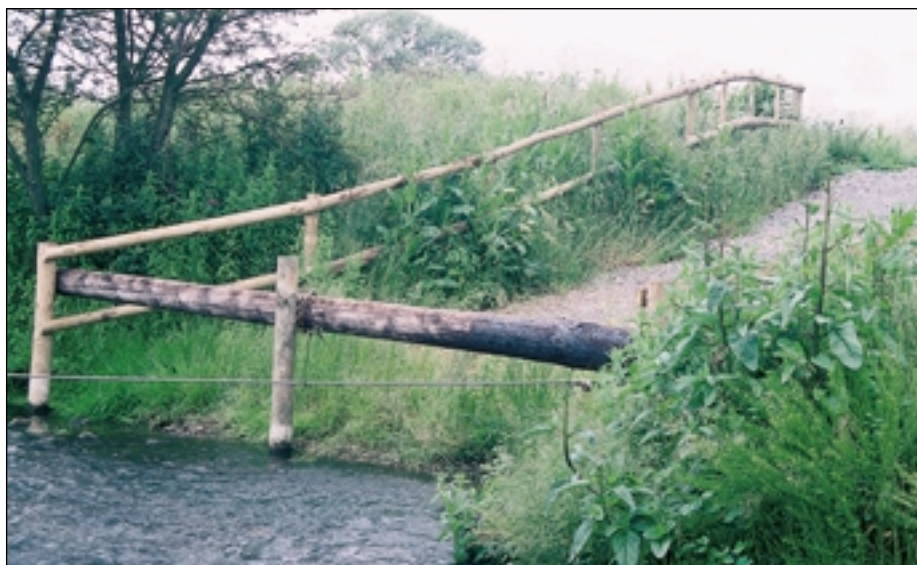
Stock watering point
at ch. 100m

Located at ch. 100m just downstream of a sharp bend in the new river course where a fast flowing riffle of gravel was expected to form. This hydraulic condition, combined with the careful contouring of the adjacent river banks, helps to avoid the risk of siltation that all too often renders watering points useless. The post and rail fencing around the ramp is tied into bank top fencing on either side, as well as across the river, to form a secure field boundary point.

The river fencing comprises a single heavy wire cable strained tightly across on a diagonal line (see photograph). The extra length of the diagonal renders the cable less likely to form a complete blockage of the river if floating debris becomes snagged on it. The angle of the diagonal is aligned to direct turbulence caused by its presence towards the mouth of the watering point, further reducing the risk of siltation.

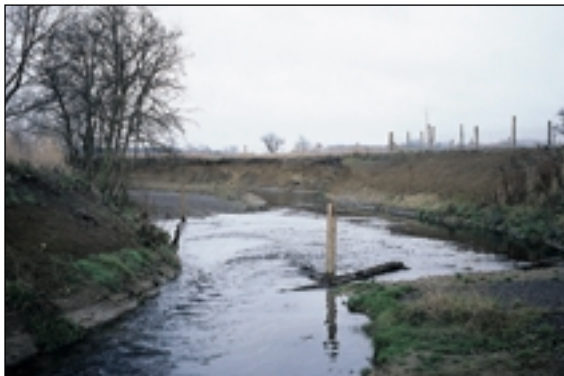
Ford at ch. 280m

Most of the ford is formed within the old backfilled river channel, which is carefully contoured to create smooth transitions with undisturbed ground on both sides of the river, as well as with the root levels of the three trees and with the newly excavated channel. The river bed and ramps are surfaced with stone over a filter fabric to suit livestock rather than heavy vehicles.

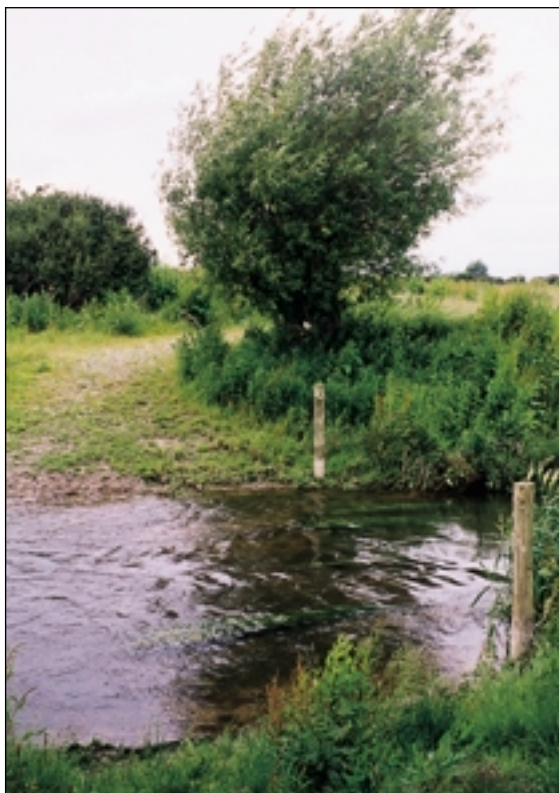
Equestrian ford at ch 620m

Despite the commonality of the design concept, each is individually configured to take advantage of local conditions and this is evident in the variety of visual interest and habitat diversity that has resulted. Of particular note, water crowfoot is thriving in the tailstone of the equestrian ford and ch. 620m.

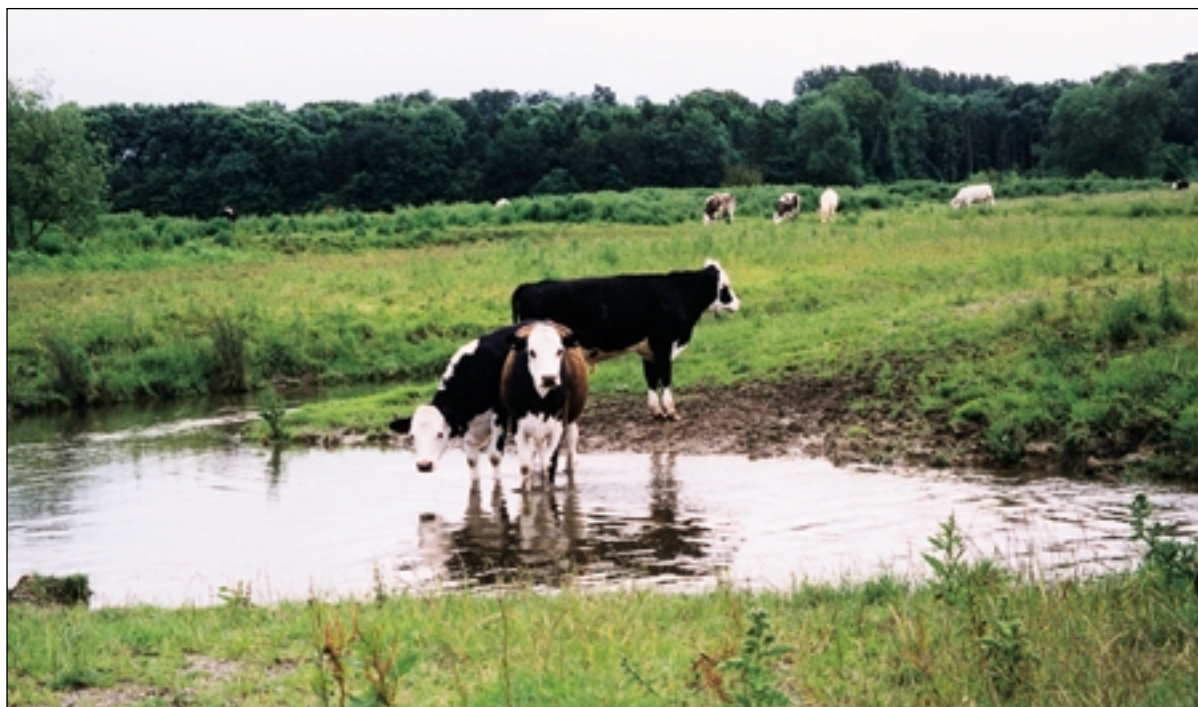
Vehicular ford upstream of mill at ch. 250m

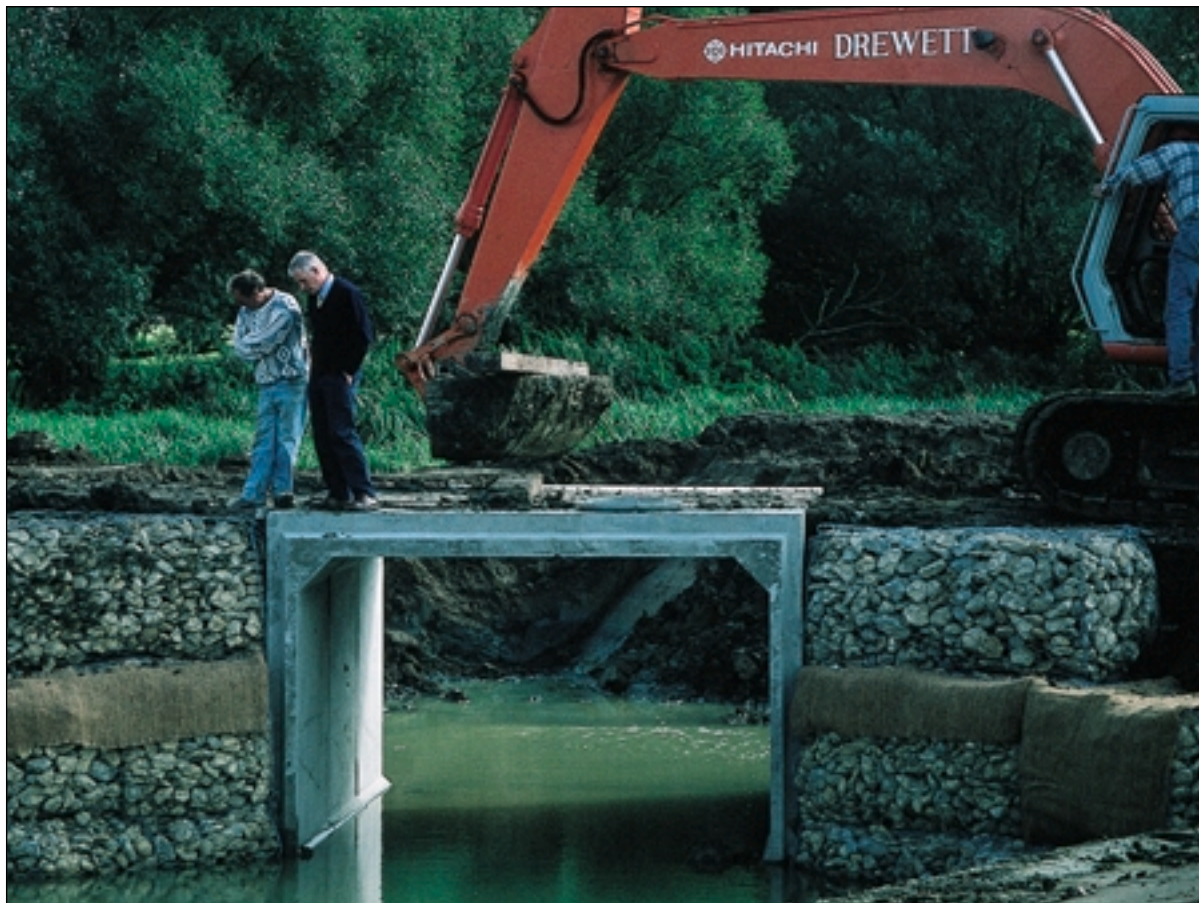
New concrete culvert crossing under construction
