RESTORING MEANDERS TO STRAIGHTENED RIVERS

1.1 New meandering channel through open fields

RIVER COLE

LOCATION - Coleshill, (Oxon/Wilts border) SU 234935

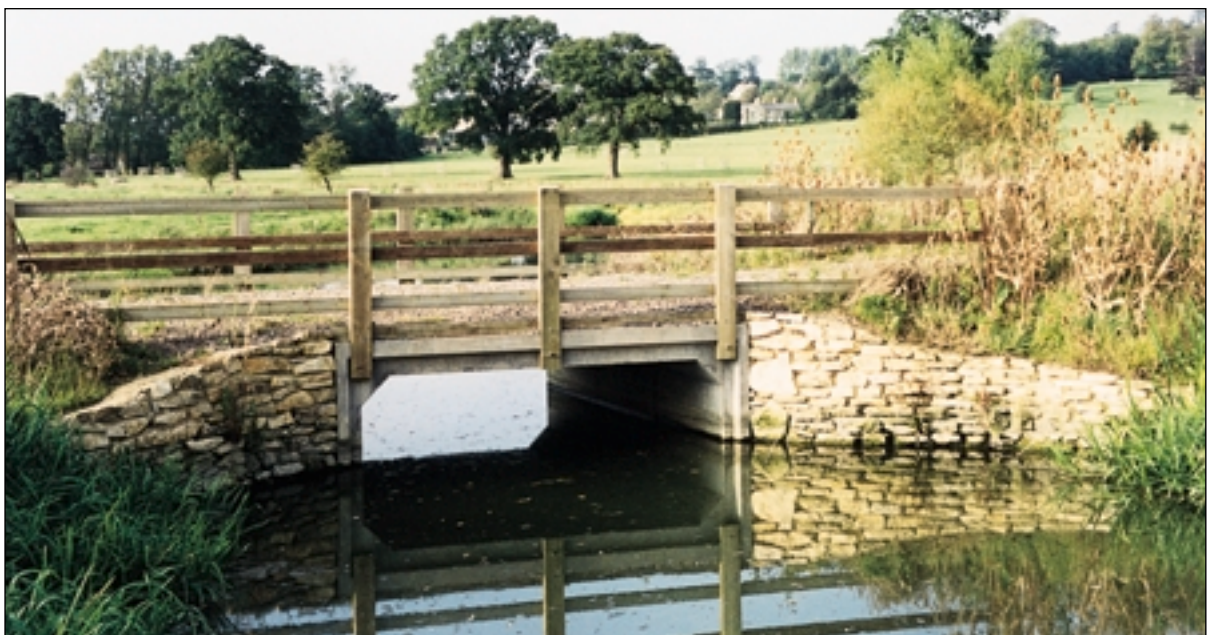
Completed 'bridge'

and stone walling are intended to draw the eye away from the concrete box which is a relatively minor feature of the overall visual aspect evident in the photo.

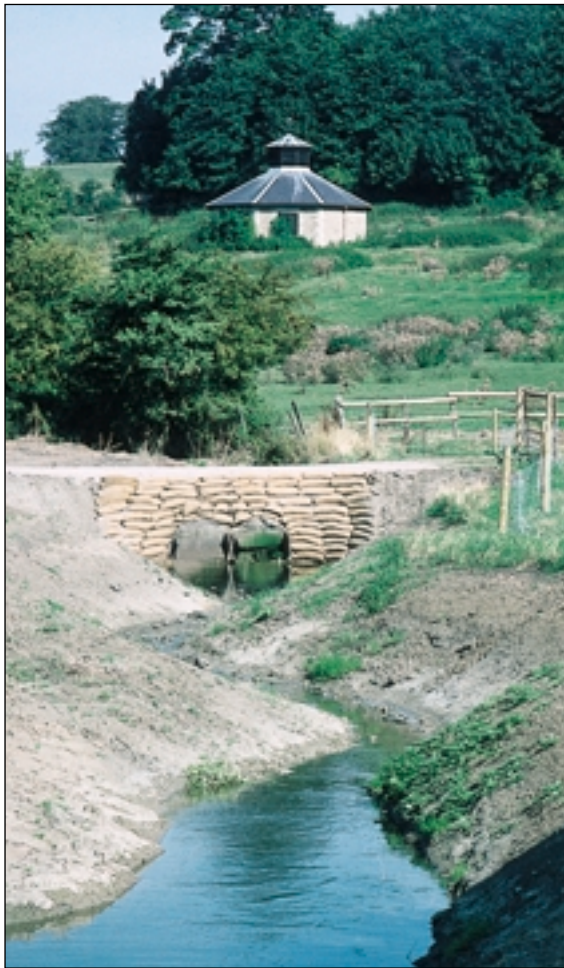
Flood drain crossing seen from bank of R. Cole.
(bagwork wing walls incomplete)

Concrete filled hessian sandbags were used to achieve this complex geometry. Another consideration was that the pressure of floodwaters passing through the pipes might produce high velocities and turbulence on exit. A distinct scour pool was excavated that was

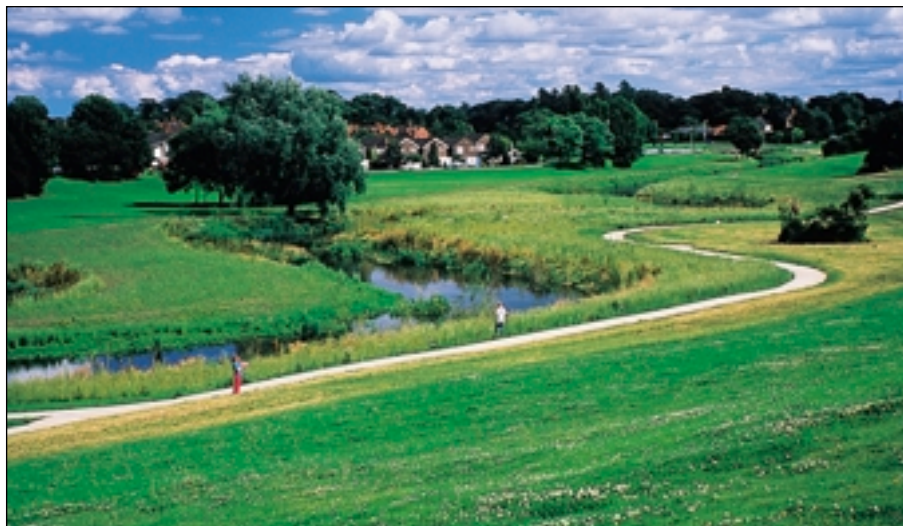
Concrete footpath and meanders

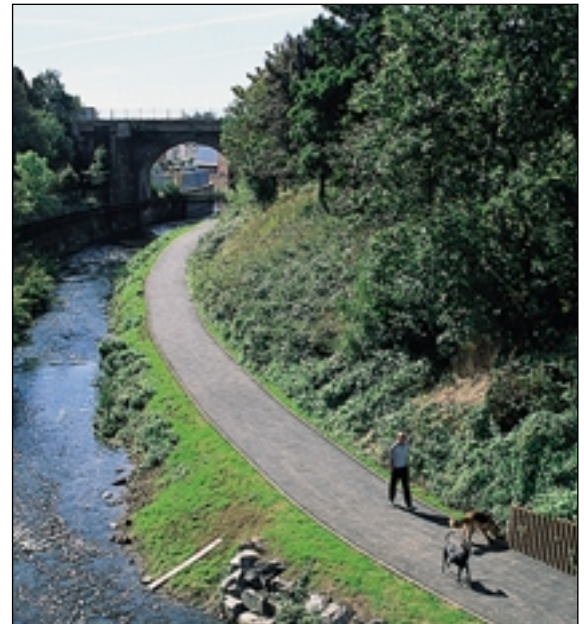
Bitmac footpath towards Skerne Railway Bridge

Bitmac Path (figs. 8.3.1 – 8.3.2)

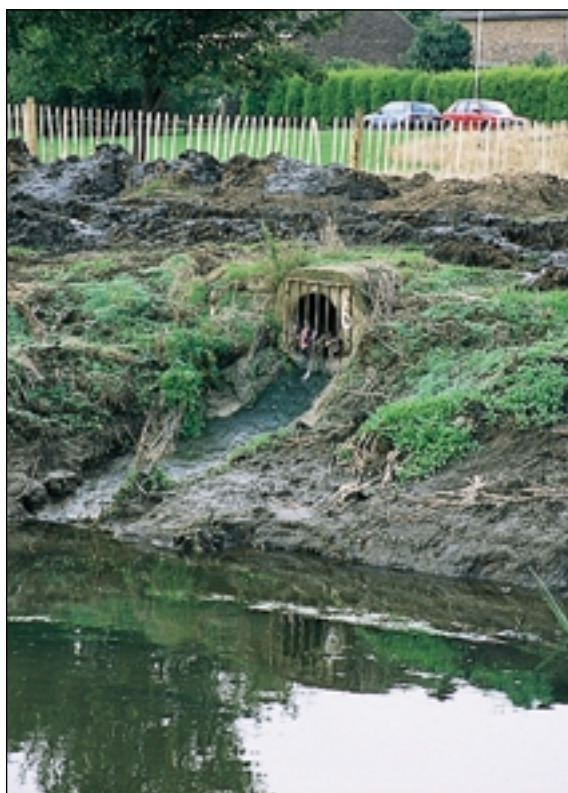
Typical outfall before replacement

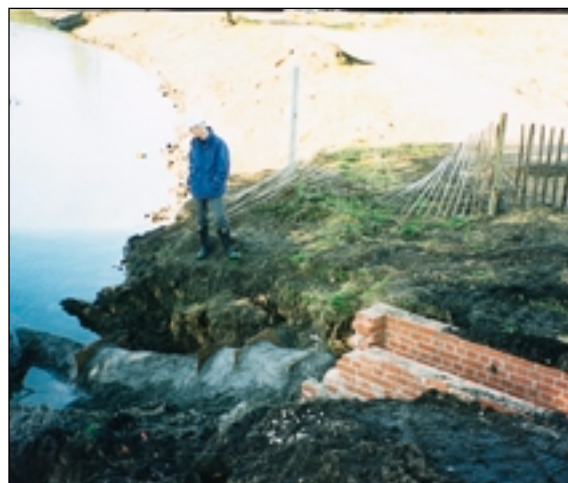
New outfall chamber under construction

NOTE: River bank reinstated with soil and toe planting such that no visual evidence of the outfall exists

Angled to discharge below low water level, the outfall pipe lies on a concrete apron which reduces scour during high flows. The outlet is turned to face downstream so that the river draws the discharge. Additionally, an underwater gabion was installed upstream of the outlet to reduce the risk of pipe damage by floating tree branches, etc. Direct jetting via the chamber is possible if outlets become silted but they are expected to be self cleansing. The velocity of discharge achievable has been seen to make the river 'boil' after heavy rain.

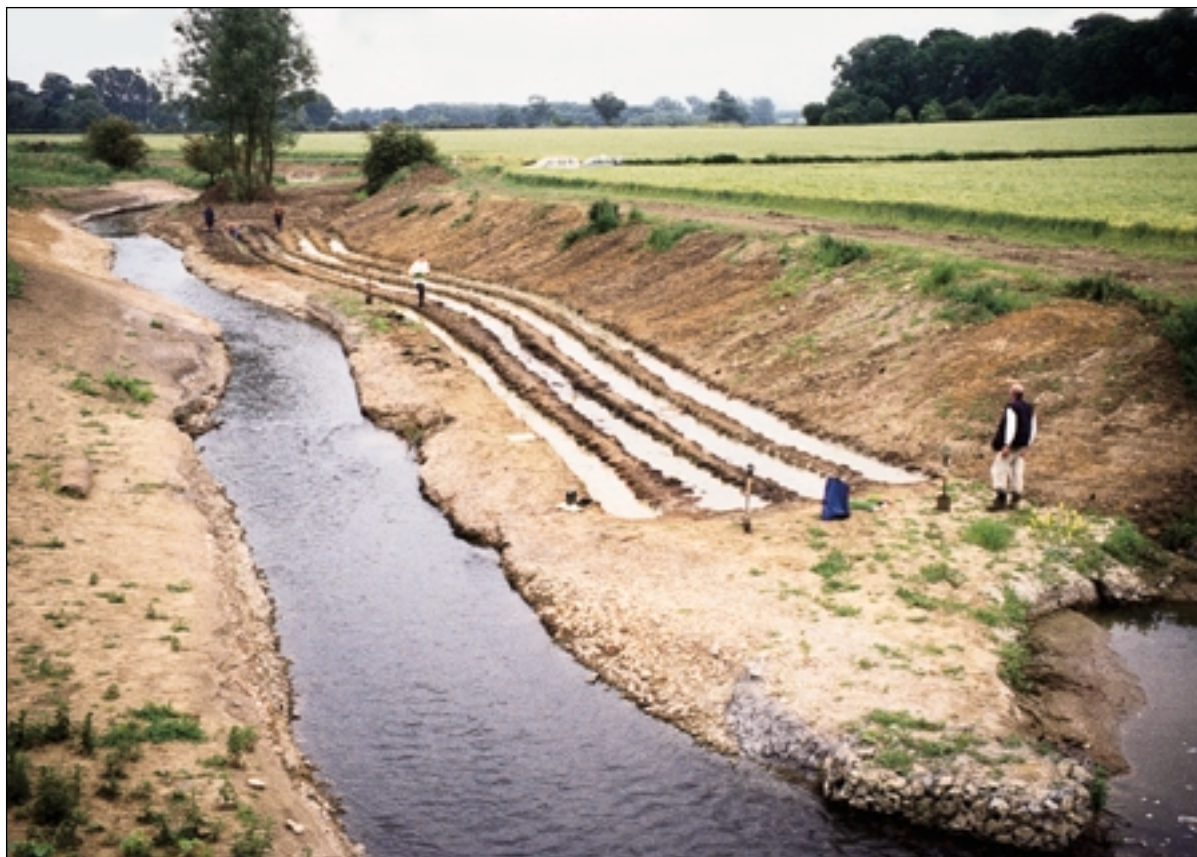
Planting reedbed – Spring 1996

Common reeds were introduced in spring 1996 using pot grown seedlings along one side of each furrow and seed along the opposite side (*fig. 9.2.3*). The use of two methods increased the likelihood of successful establishment and enabled the performance of each to be monitored.

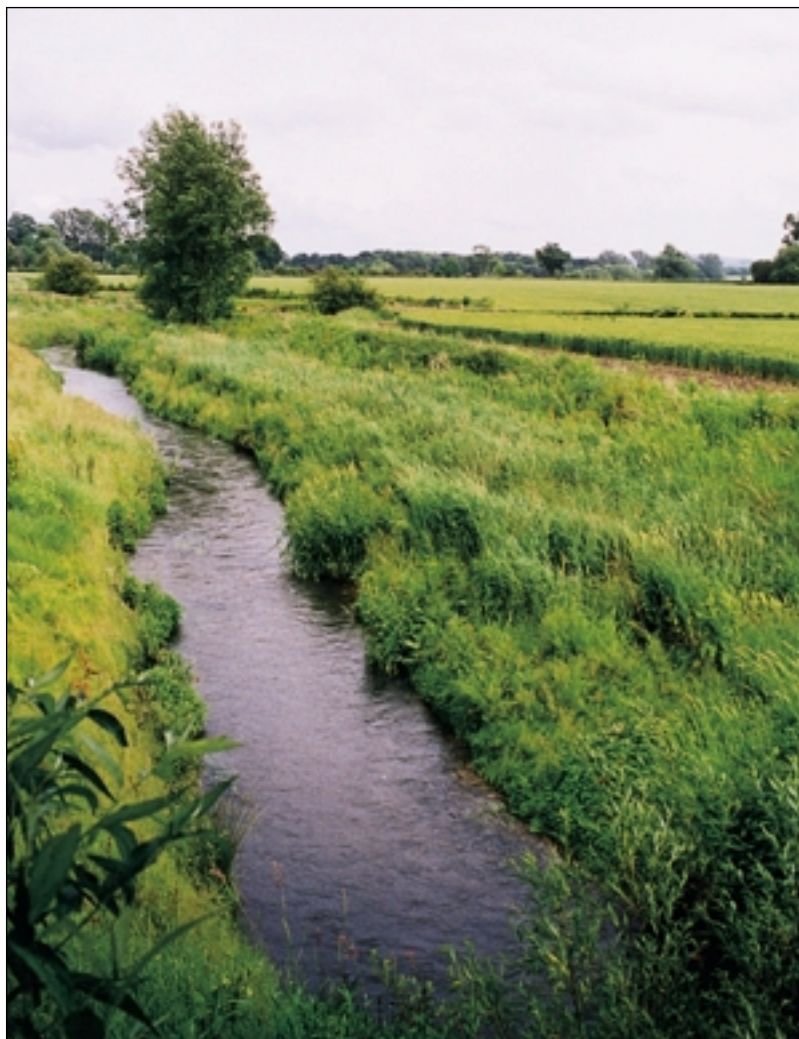
Reedbed established – Summer 1998

The reedbed established exceptionally well with 93% of seedlings surviving to maturity, although seed germination was perhaps only 50%, but still sufficient to achieve full colonisation within two growing seasons. Other aquatic species colonised the area naturally, including greater water plantain and soft rush. Concerns that the River Cole might damage the reedbed when in flood proved unfounded because the

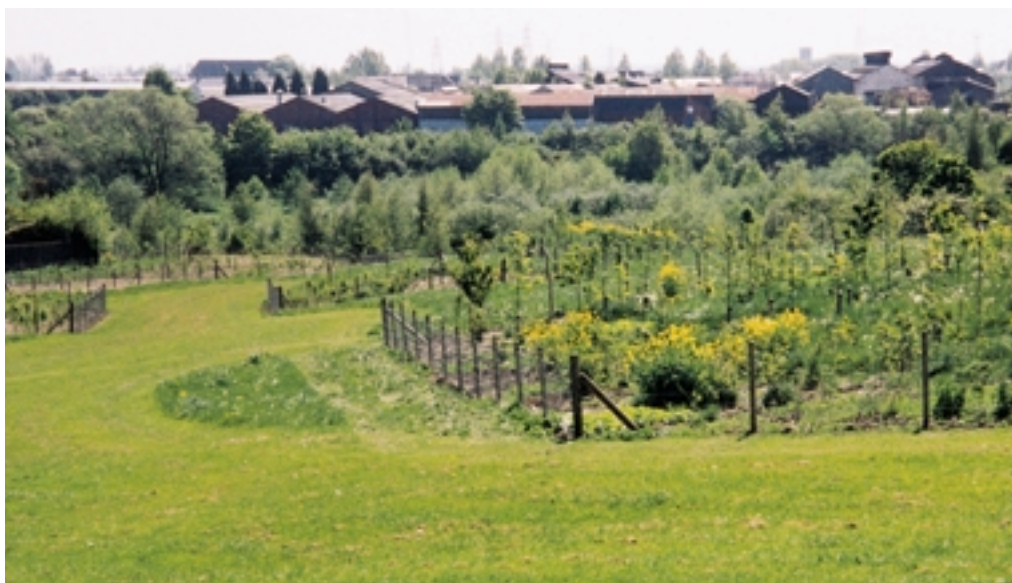
Rockwell after landform completion – 1998

The landform of the two areas was generally designed to simulate naturally occurring 'gullies and hummocks' found in some parts of the north of England. Involvement of the community including schools, local wildlife trust and residents was deemed essential. Ideas for formal and informal paths were included for use in the detailed design.

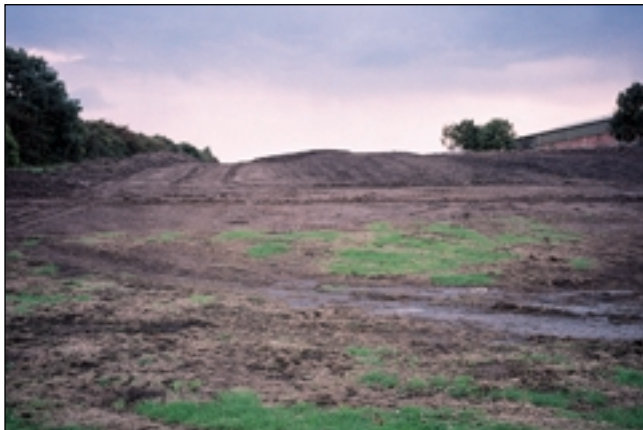
Keepsafe landform during construction

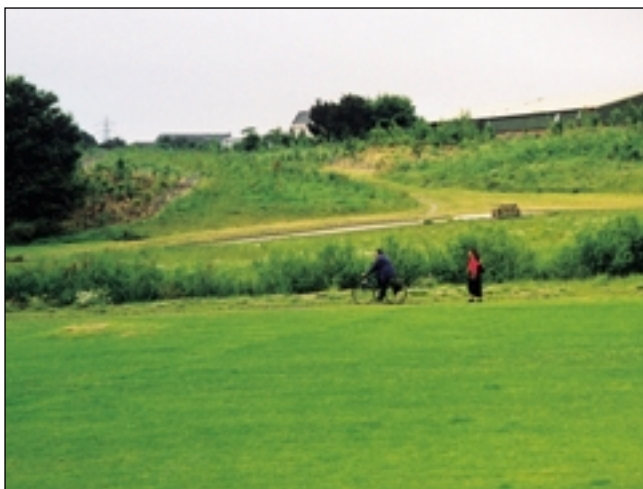
Similar view of Keepsafe after tree planting – 1998

Participation in landscape design and planting has given the community ownership of these open spaces and may be a factor in the minimal level of vandalism experienced. Both areas blend with the surrounding landscape and they are not obviously artificial. Each is now more widely used by walkers taking natural desire lines. The tree and shrub planting is already helping to screen the industrial area and the railway.

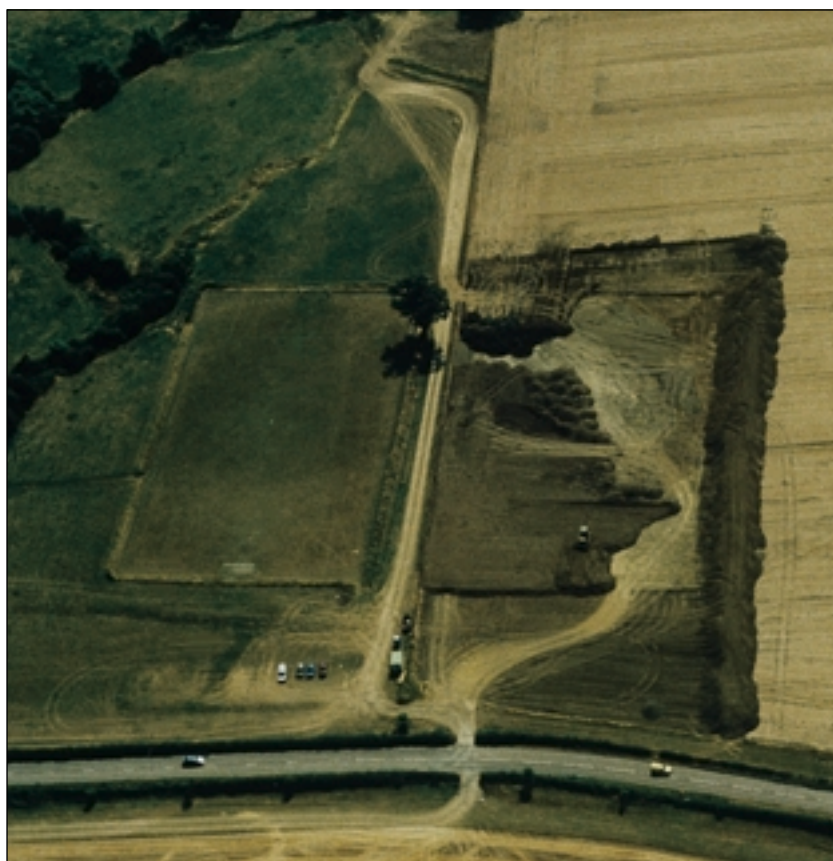
Construction of landform
in arable field to right of
football pitch – 1995
Photo: Environment Agency

Excavation to create over 1 km of new meandering river channel resulted in c. 4,000m³ of spoil that needed to be transported away from the riverside. This was used to re-contour a nearby area of sloping arable field just off the floodplain. The landform created resembles a natural river terrace. It is large enough to serve as a second football pitch to compliment an existing pitch located on the adjacent floodplain, if needed. In addition, shallow mounds
